# **CUNNINGHAM PRESERVATION PROJECT**

## **GRAND TETON NATIONAL PARK MOOSE, WYOMING**

### **HISTORIC STRUCTURES RECORD OF TREATMENT**

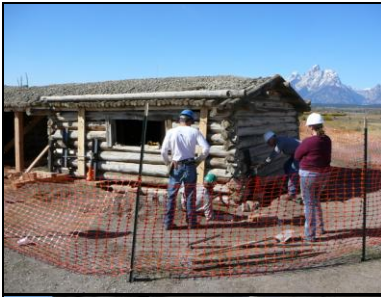
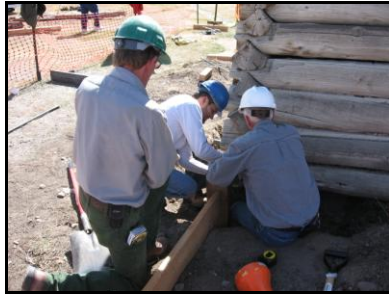
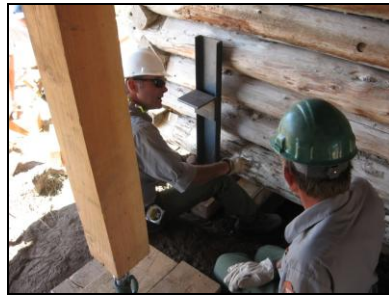
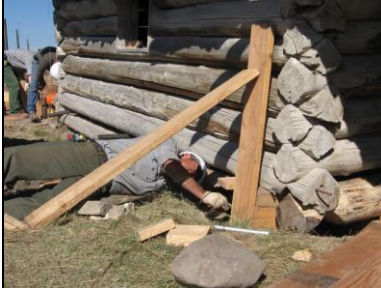
### Phase Three: Moving the Building

Moving the structure required the several workers. At times, there were two jacks going at once, one person watching the roofline to alert others of possible damage to the structure and another tightening the jacks that supported the posts on the roof as the structure shifted.

The two photographs on the right show the movement of the building vertically and horizontally. In the first photo, the new sill log had been put in place and is supported by new field stone taken from a local source. The second photo shows a movement of approx. 3 inches of the northwest corner of the north room.
